**FHWA/IN/JTRP-99/4**

**Final Report**

**EMBANKMENT WIDENING DESIGN GUIDELINES  
AND CONSTRUCTION PROCEDURES**

**September 1999**

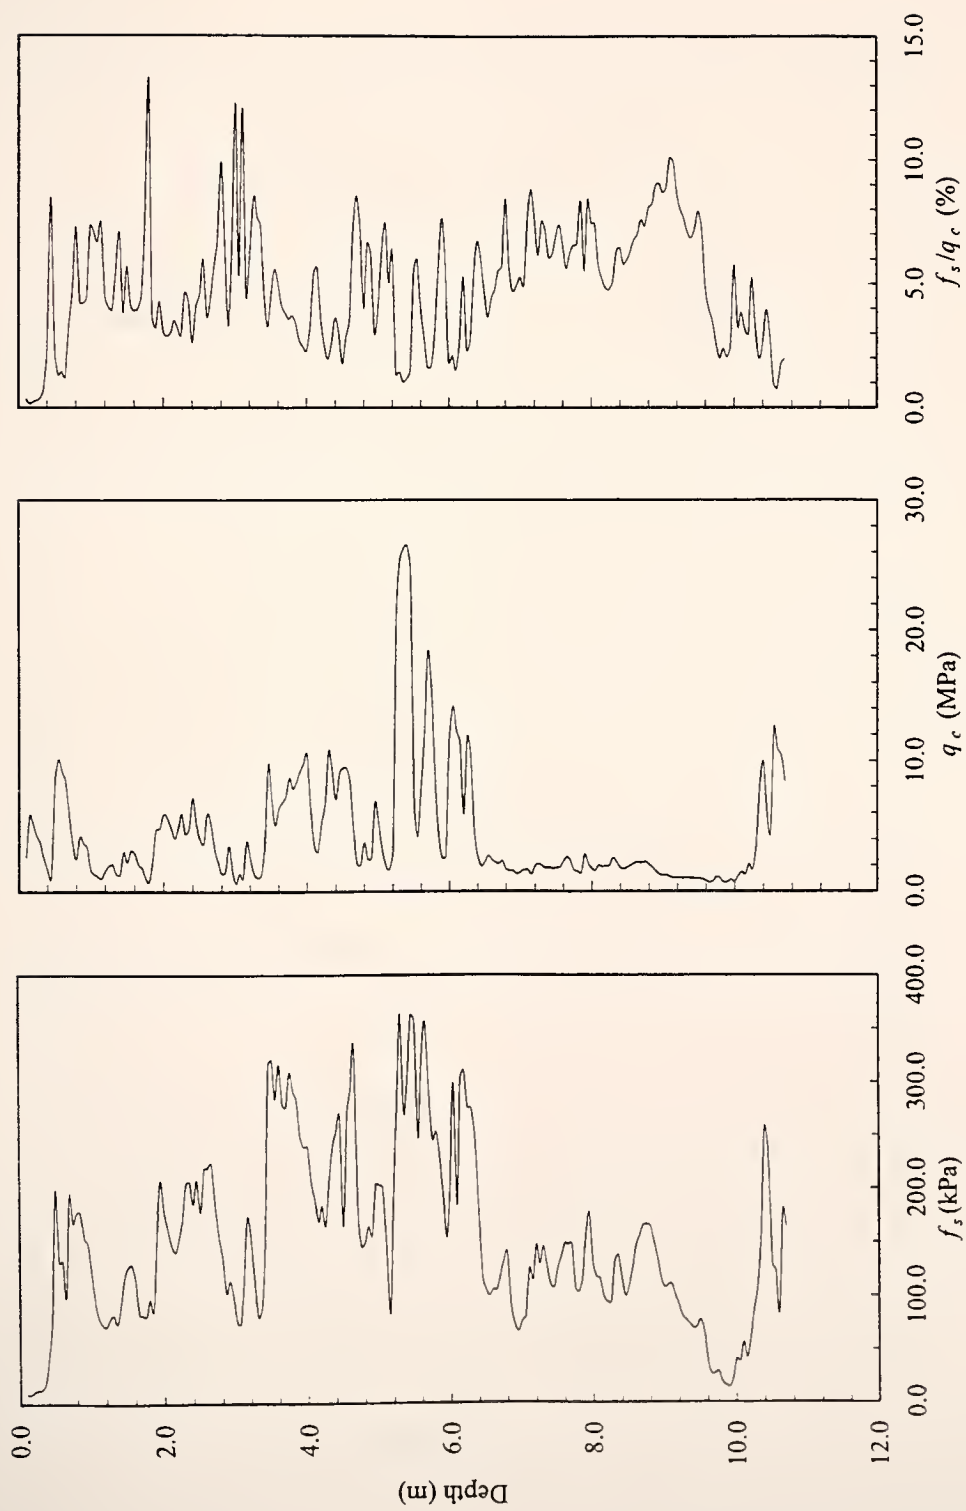
Figure 4.5. Cone penetrometer test data, CPT-710, Sta. 18+874, O.S. 23.48m lt., I-69, Madison County, Greenfield District.

Two cone penetration tests (CPT) were performed at this project site by Purdue University. CPT data are presented in Figure 4.5 and Figure 4.6. The tests were performed adjacent to the shoulder of the highway, offset approximately 6 feet from the edge of pavement. CPTs were performed to evaluate the consistency of the embankment. CPT provides a continuous profile of sub-surface stratigraphy; therefore, it is a superb tool for identifying soft zones or other discontinuities in natural and man-made deposits. No apparent weak zones or discontinuities were identified at the locations of the CPTs.

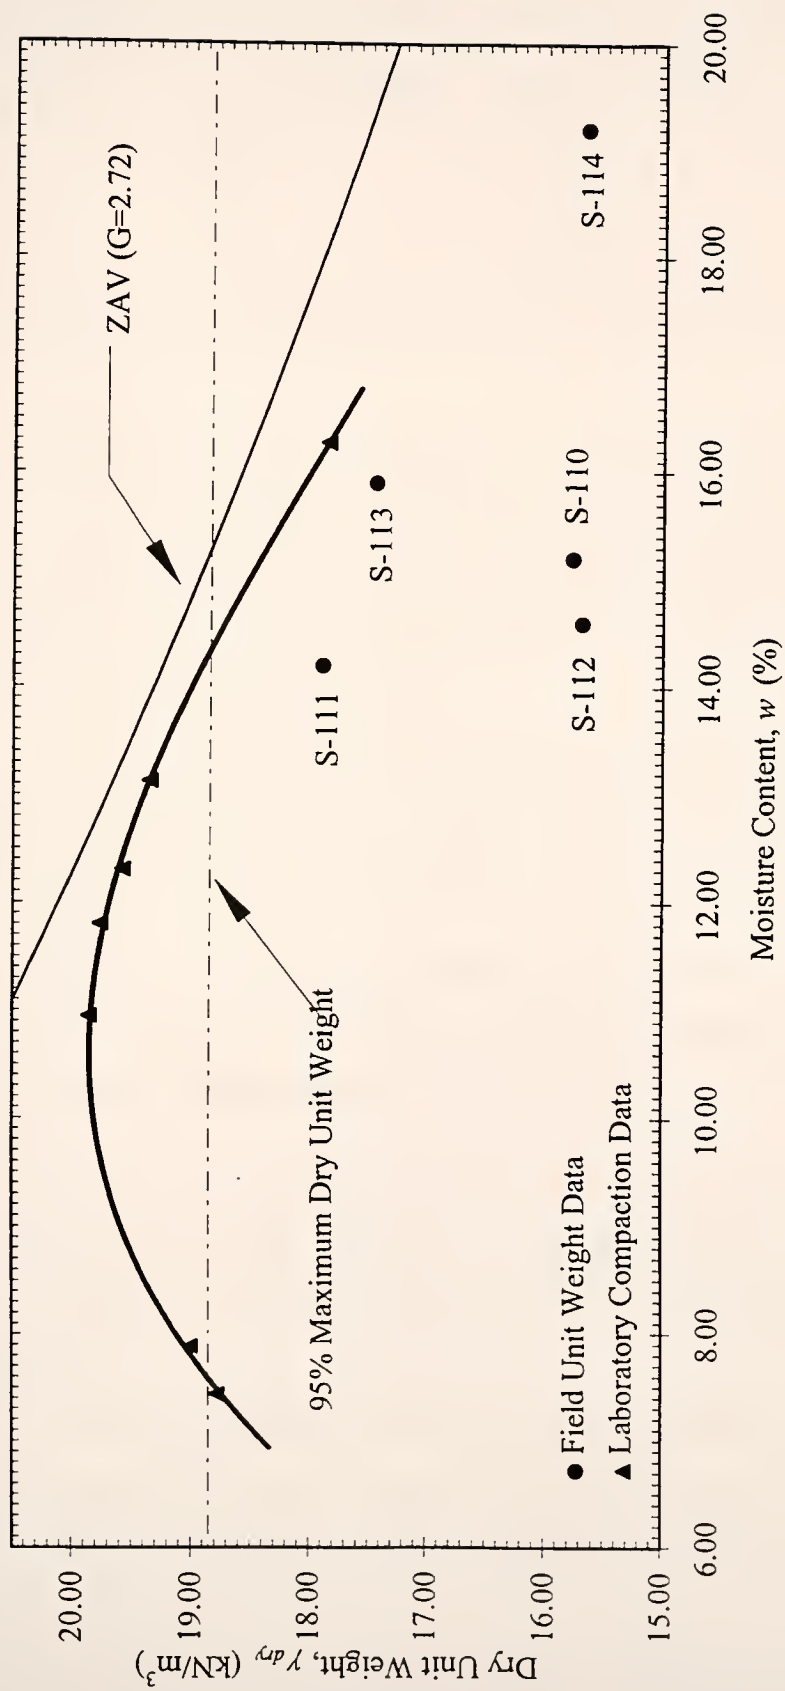
Figure 4.7. Standard Proctor test data and sand-cone data, I-69, Madison County, Greenfield District.

As indicated in Table 4.4, the maximum dry density determined from standard Proctor tests ranged from 1,925 to 2,024  $\text{kg/m}^3$ , and the optimum moisture content ranged from 10.5 to 13.3 percent. Sand-cone tests indicate that relative compaction of the fill used to widen the embankment ranged from approximately 79 to 90 percent. In addition, the moisture contents determined for the field density tests indicate that the soils ranged

from 3.7 to 8.7 percent wet of optimum. These data and the moisture density relationship are presented in Figure 4.7.

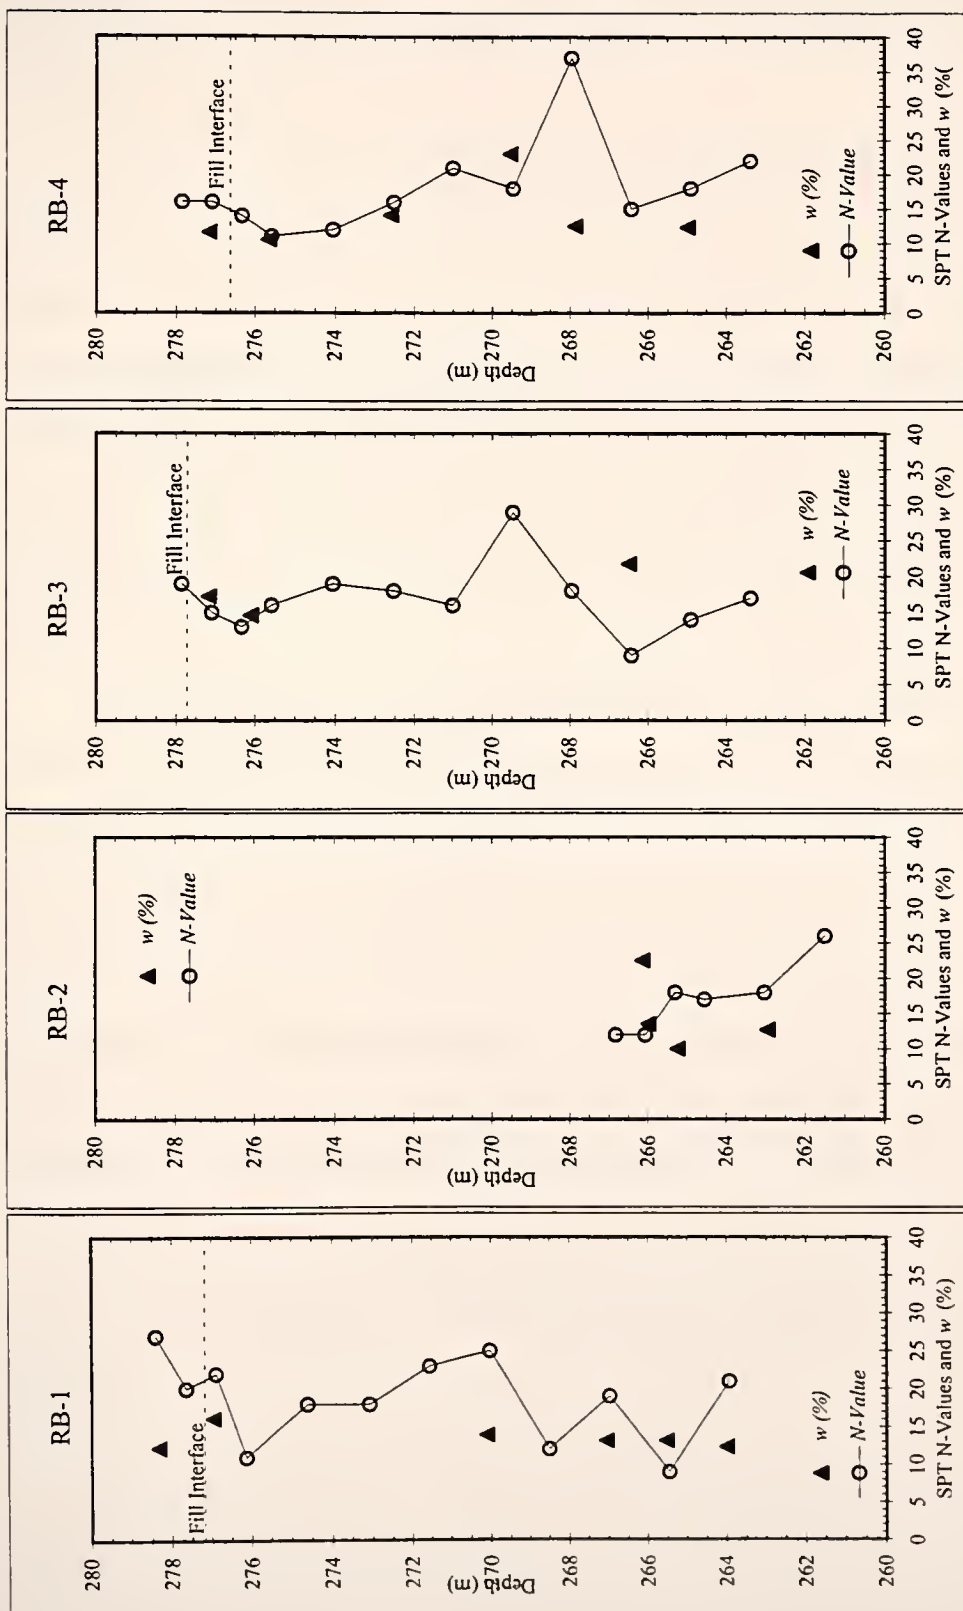
Figure 4.11. Standard penetration test data and water content profiles, I-69, Grant County, Fort Wayne District.

Four borings were advanced by INDOT subsequent to failure. SPT and moisture content profiles are presented in Figure 4.11. RB-1, RB-3 and RB-4 were advanced through the embankment. RB-2 was advanced at the toe of the embankment. The maximum estimated depth of the fill ( $\approx 1.83\text{m}$ ) based on sideslope geometry is presented on the profiles; however, observations made in test pits indicate that the depth to original

ground was shallower. The borings indicate that the consistency of the soil comprising the embankment and foundation is stiff to very stiff. No weak zones indicative of a rupture zone were noted.
